AEG Outstanding Environmental & Engineering Geologic Project Award

Paw Paw Slope Stabilization – Chesapeake & Ohio Canal National Historical Park

Project Design-Build Team

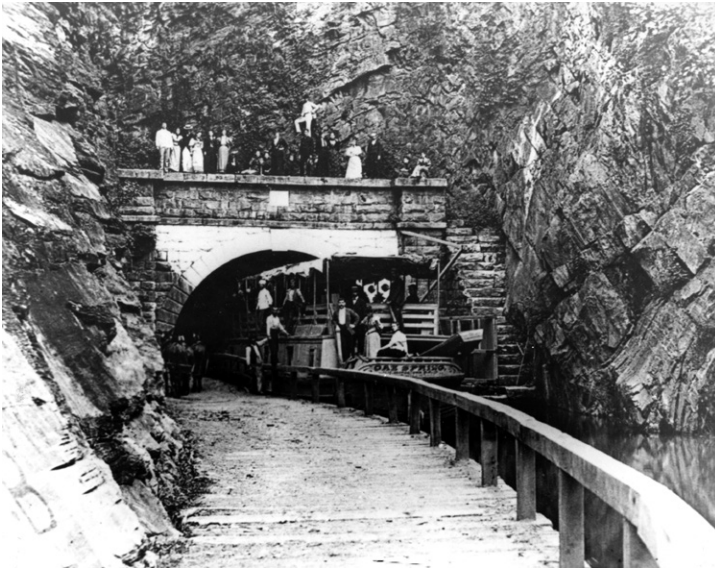
Figure 2, Paw Paw Tunnel and North Approach through the Deep Cut, 1890

Fall (RF) Area 9. The 2017–2019 effort included limited rock scaling, installation of rock bolts, use of precast reinforced concrete shear blocks, draped mesh, and weep drains within RF Areas 2–7. Figure 2 shows the North Portal of the Paw Paw Tunnel through the “open cut” approach, and Figure 3 shows the slope stabilization work in the 1950s. The extent of rockslide that occurred in 2016 is included in Figure 4 and shown in aerial footage in Figure 5. It should be noted that an additional area of potential slope instability was identified by the contractor after initial award of the design-build contract.

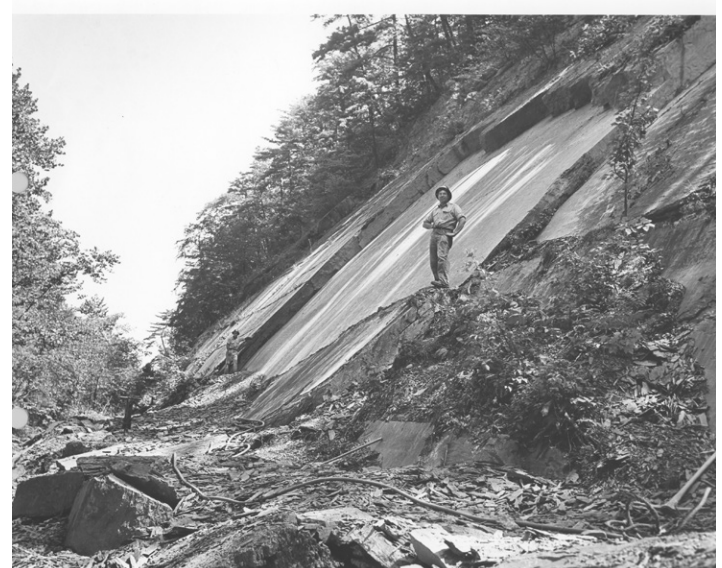
Figure 3, Rock bolting and scaling by NPS in 1950s

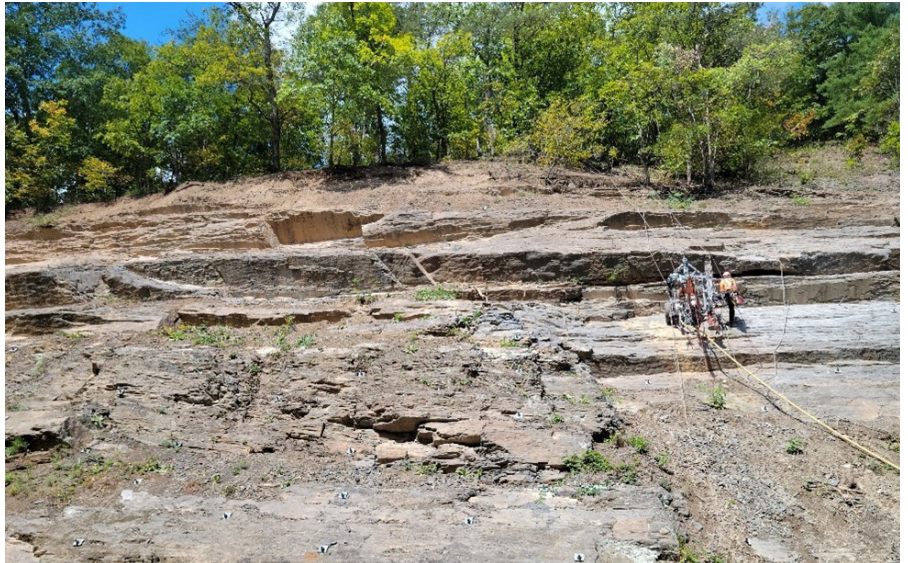
Figure 8, Rock anchor installation by rope access and wagon drill, typical

Once scaling was completed in each of the designated RF areas, the installation of pattern and spot anchors began. The majority of the pattern anchors consisted of 8-foot-long #10 galvanized threaded steel bars placed on an 8-foot x 8-foot pattern. While the design called for resin encapsulation of the bolts, some of the anchors required cement encapsulation because of the weathered nature of the bedrock. Spot anchors consisted of 10- to 20-foot-long #10 galvanized threaded bars. It was originally envisioned that the rock bolts would be installed utilizing a Pegasus Drill staged at the bottom of the canal. However, because of the unforeseen active slide that had to be removed, the only area that was able to utilize the Pegasus Drill was RF011. The majority of the anchors were installed utilizing wagon drills with rope access and rope access drill technicians (Figure 8). In all, DTDS installed over 10,000 LF of anchors.

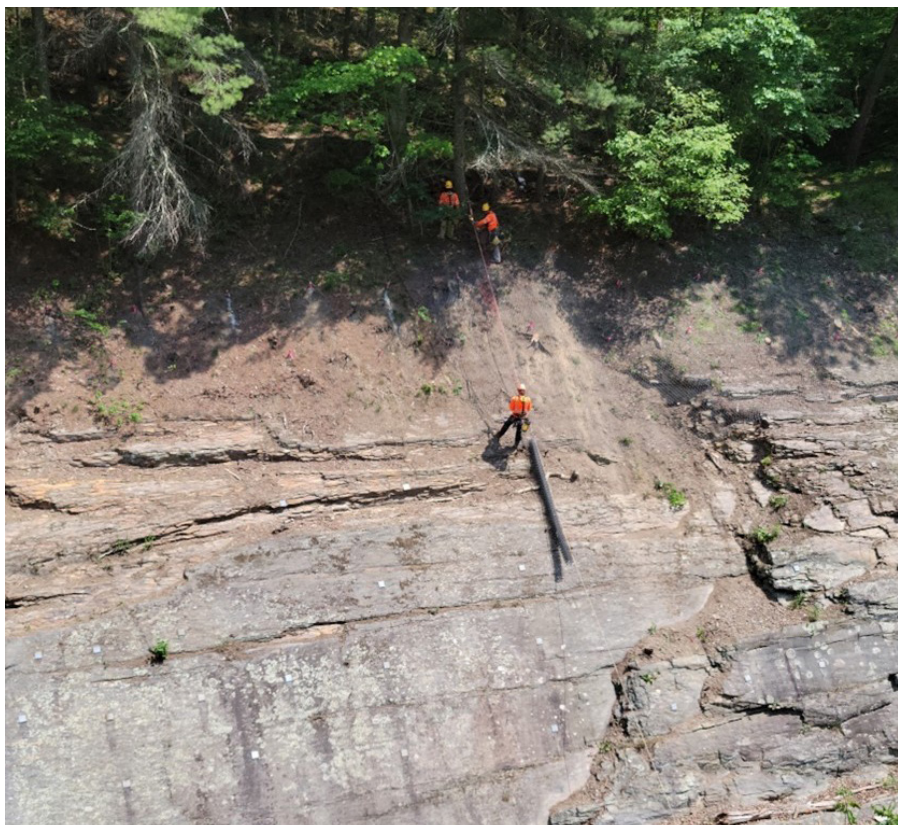
Figure 9, Placement of pinned Geobrugg Tecco® mesh

The design-build contract originally envisioned RF protection mesh in the areas downstream of the North Portal in RF04–RF08 and not directly adjacent to the historic portal of the Paw Paw Tunnel. After detailed analysis by Brierley Associates, it was determined that additional RF protection mesh would be required in RF02 and RF03, directly above the boardwalk carrying the C&O Canal towpath and adjacent to the Paw Paw Tunnel North Portal. Elevations of the bottom of the RF mesh were carefully coordinated to try to limit accessibility for unauthorized climbing by park visitors, while balancing the need to mitigate the potential for spalling rock to endanger the traveling public. A Geobrugg Tecco® mesh was utilized and powder coated in a hue to blend into the existing rock face geology in order to minimize the visual impact. Over 30,000 SF of Tecco® mesh was installed between RF002 and RF08, also by rope access drill technicians (Figure 9).

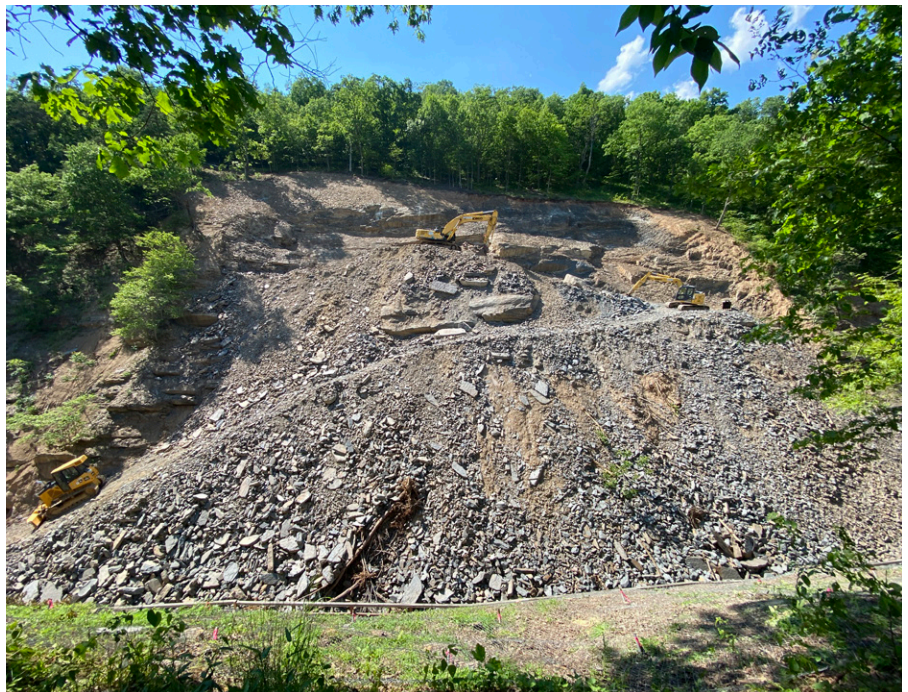
Figure 11, Establishment of switchbacks and removal of additional slope concern area and 2016 rockslide

In close coordination with Brierely, NPS, and DTDS, it was decided to mechanically remove the active slide material rock utilizing hydraulic excavators and breakers. To access the active slide from the north, switchbacks were installed within RF13 utilizing existing scaled/fallen rock to allow the excavators to reach the upper limits of the slide (Figure 11). This work became the critical path of the project and extended the schedule.

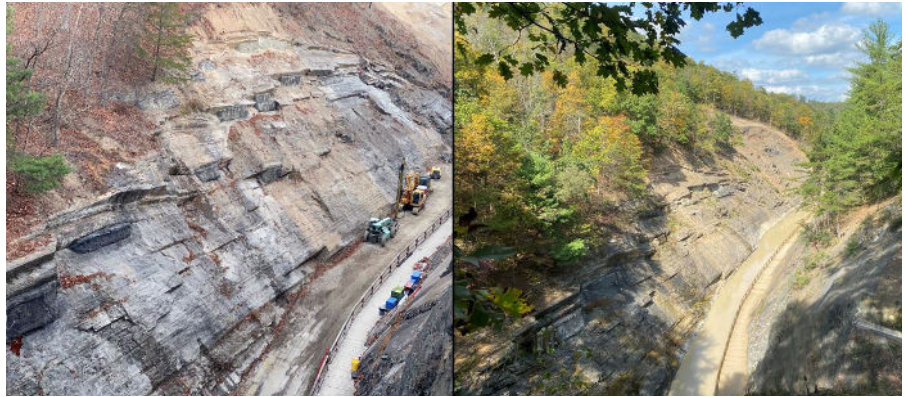
Figure 12, Finished shear blocks, one week following initial staining in November 2022 (left) and after 11 months of weathering/patina (right)

The lateral and upslope extent of the exposed rock slabs within RF11 necessitated the installation of shear blocks to provide additional support. The original schematic design included in the request for proposal envisioned large, discrete cast-in-place steel-reinforced concrete wedges spaced at regular intervals. DTDS submitted a request to use hand sculpted shotcrete along the entire length of each proposed shear block location, and a full-scale mock-up was created at the DTDS laydown area. The approved shear block concept included rock anchors installed at the toe of the slabs, along with rebar, welded wire mesh, and drainboard to reduce the buildup of hydrostatic pressures.

Once it was determined that the sculpted shotcrete shear blocks could be utilized, an additional mockup was constructed whereby NPS personnel could observe the appearance of the finished product. A water-based stain was used to result in hues that, in combination with the sculpting, blended so well into the adjacent geology that some visitors to the site had difficulty identifying the locations of the newly installed shear blocks. The sculpted and stained shotcrete was utilized on the remainder of the shear blocks with great success, minimizing the impact to the cultural landscape. A comparison of the appearance approximately one week after initial staining to that with approximately 11 months of weathering/patina is included in Figure 12.

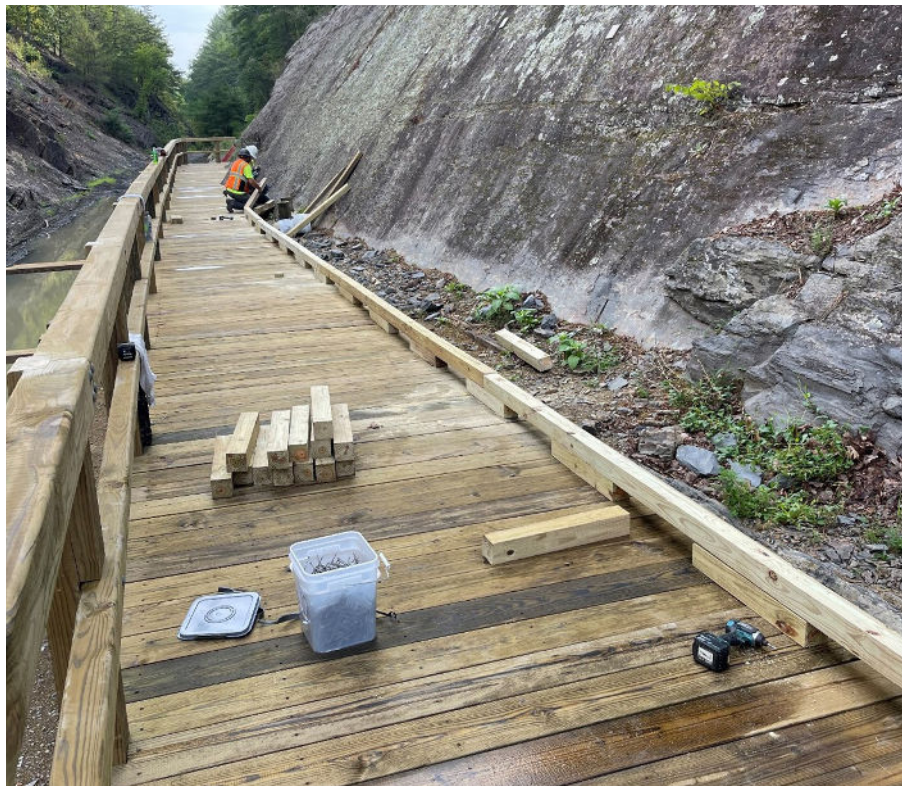
Figure 13, Boardwalk construction

The design-build contract called for the demolition and reinstallation of an approximately 700-foot-long wooden boardwalk connecting the portal of the tunnel to the rock toptowpath to the north of the site. Boardwalk construction occurred at the end of the project, once stabilization of the adjacent slopes was completed. The boardwalk design met the most recent codes and standards, most notably installing the vertical support posts on 8-foot centers with proper cross-and-angle braces. Greenway Bridge Company, the boardwalk subcontractor, was required to cut each of the deck boards within a tight tolerance to match the uneven rock face along the length of the boardwalk (Figure 13). Close coordination and adaptative design were required to avoid damaging the historic features that were to remain; including the

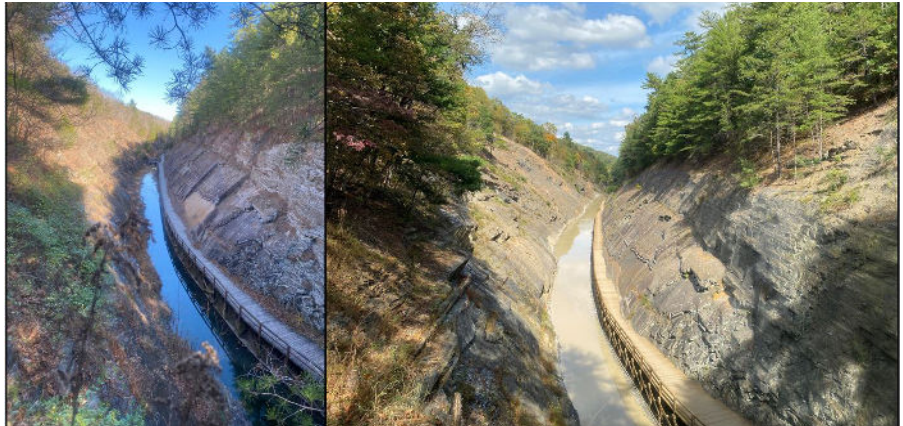
Figure 14, Paw Paw Slope Stabilization Project—As viewed from above the north portal of Paw Paw Tunnel (November 2020 on left and October 2023 on right)

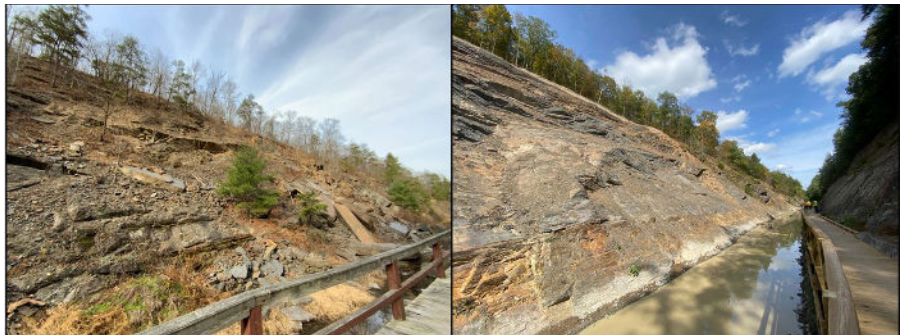
Figure 15, Paw Paw Slope Stabilization Project – As viewed looking north at the 2016 rockslide (November 2020 on left and October 2023 on right)

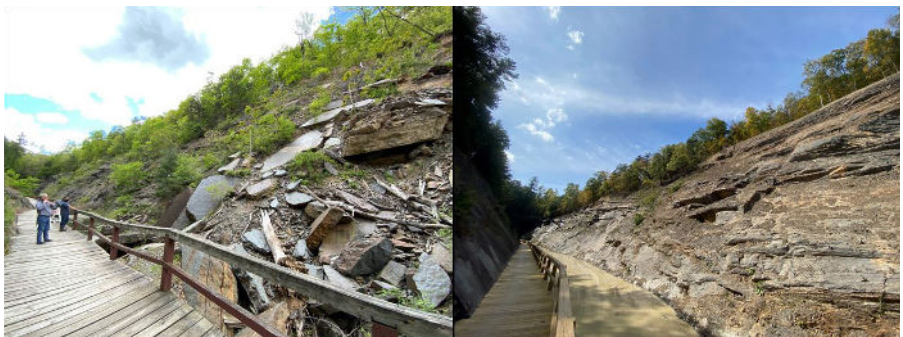
Figure 16, Paw Paw Slope Stabilization Project – As viewed looking south at the 2016 rockslide (May 2021 on left and October 2023 on right)

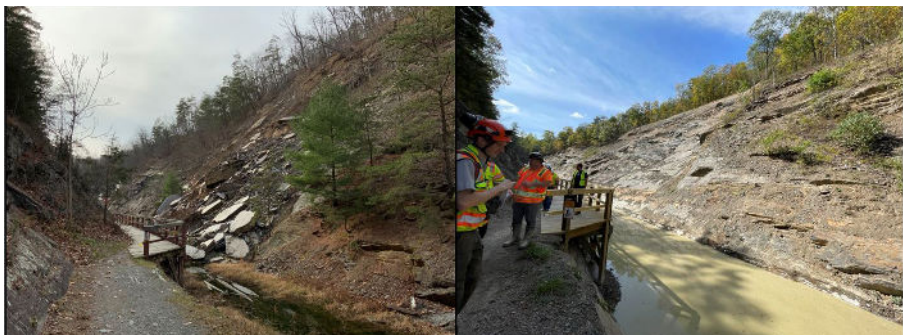
Figure 17, Paw Paw Slope Stabilization Project – As viewed looking south at the 2016 rockslide (November 2020 on left and October 2023 on right)
